**ADDENDUM NO. 1**  
TO  
PROCUREMENT AND CONTRACTING REQUIREMENTS  
FOR  
**Riley Village Sanitary Sewer Project (Both Divisions)**  
FOR  
NINESTAR CONNECT  
Issue Date: April 17th, 2024

## TECHNICAL MEMORANDUM

Re: Task Order No. 7 – Riley Village Wastewater Collection System Investigations,  
CCTV Review

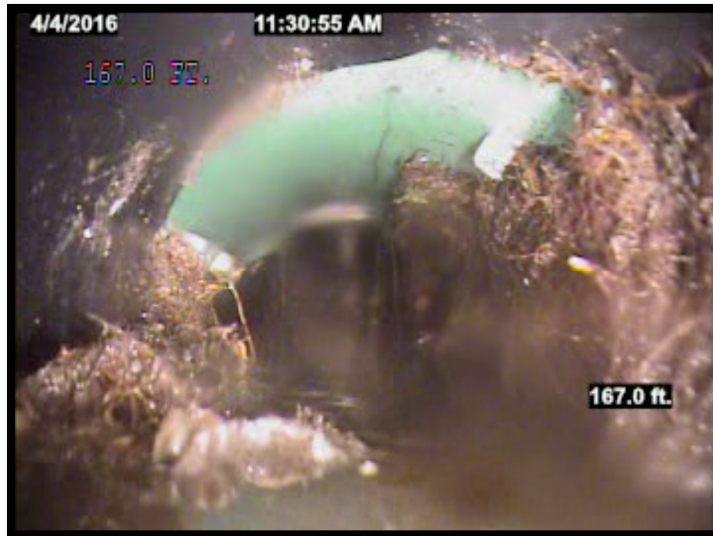
- i. 167 LF from MH R6 (estimated 5 foot repair)

Point repairs are recommended at those locations where the pipe is failing and cannot be corrected with pipe lining. Point repairs are recommended at the following locations (all Priority 1):

The pre-design construction cost estimate for three (3) point repairs is 3 x \$15,000 = **\$45,000.00**

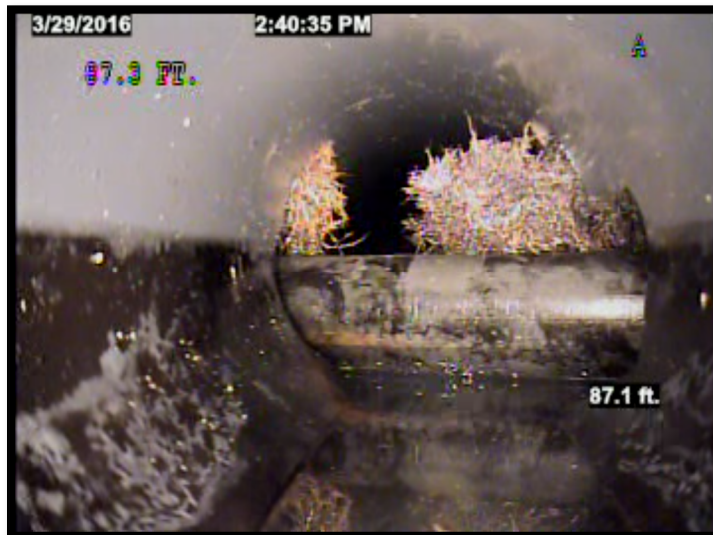
- ii. 87.3 LF from MH R11 (estimated 3 foot repair)

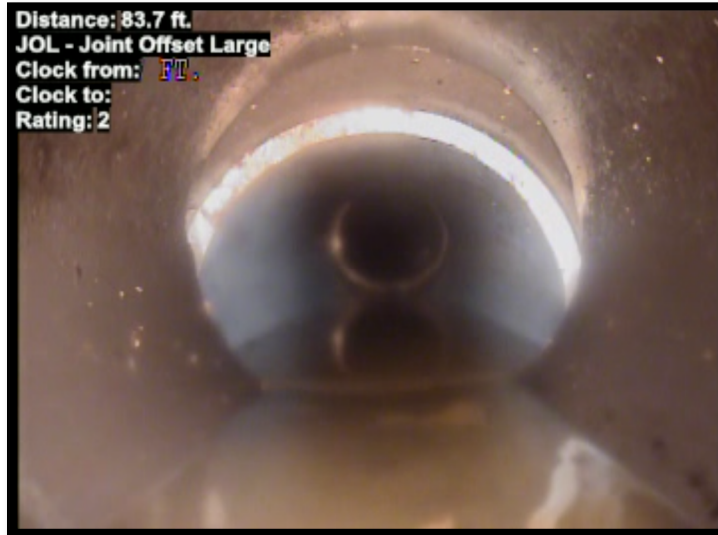
- iii. 83.7 LF FROM MH R16 (estimated 5 foot repair)
